AMS02-TCS

Doc.Nº: NCR-TCS-CGS-C-013

2 NCR Title: RAM and WAKE Radiators edges covering										
		odel 6	Subsystem 7	Procedure/Work Item Nº						
IDENTIFICATION		M S	M & T	rooddalarffolk Rolli IV						
	AIDC 1/008/08/0 F	IVI	RADIATORS	1						
	8 NC ITEM Identification 9 Drawing Nº. Rev.	10 P.N. / C.I.		11 Serial Nº						
	RAM RADIATOR ASSY 21-AMS-000.00.00 B	21-AMS.000.	New York	01						
	WAKE RADIATOR ASSY 22-AMS-000.00.00 C	ADIATORAGOT								
	(AFE for CGS)									
	12 Next Higher Unit Id.	14 P.N. / C.I.	Nº	15 Serial Nº.						
	3			N.A.						
	N.A.	N.A.		N.A.						
	16 NON CONFORMANCE Detected During:	NON CONFORMANCE Detected During:								
	RECEIVING INSP. MANUFACT. ASSEMBLY/INTEGRATION X FINAL INSPECTION TEST OTHER									
z	17 Initiator, Dept., Date, Signature L. Cremonesi QA 08.09.2									
RIPTION	18 Description of NON CONFORMANCE	/	19 Requ	irements violated						
-F										
O	Theedge radius of the Main RAM and WAKE Ra	diators is n	ot in

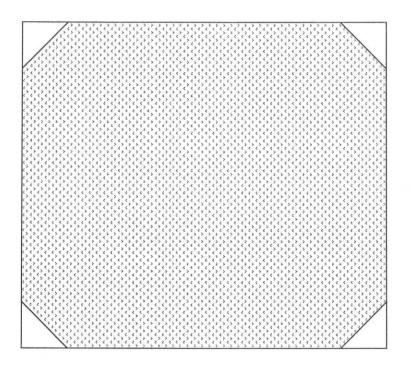
ANNEXE 1: P/C/008 - Rév. 2

Eprouvette traitée avec PSX + SG121FD ALCATEL ALENIA SPACE

Zone peinte

Zone d'épargne pour bridage dans conteneur
